Condition monitoring of gearboxes using Acoustic Emission

SCHOOL OF ENGINEERING

PhD THESIS

July 2010

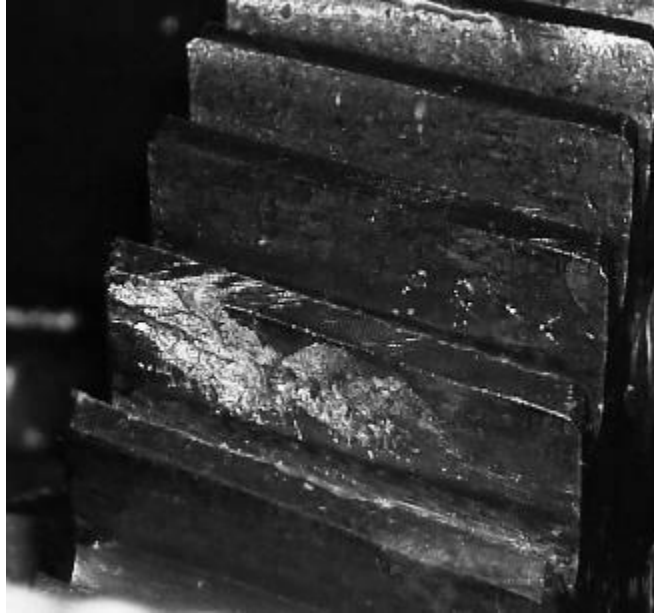
Figure 31 Seeded defect on the tooth

drill, see Figure 31. The gearbox was then started, and vibration and AE data for the time frame encompassing the damaged tooth were acquired instantly. The significance of the instantaneous recording was to allow the author to explore the influence of surface/material deformation on the levels of AE and vibration as some investigators had suggested [94, 155]. The gearbox was allowed to operate until the temperature reached 60°C after which AE and vibration signals were again recorded for the specific defect condition. The same procedure was repeated at 250 Nm and 180 Nm. The test sequence continued for six more defect conditions, as detailed in Table 6. Eventually, four sets of data for each defect were produced. The first was associated with data at 380 Nm torque, captured immediately after the defects were generated, and referred to as ‘D’ throughout this report. Other sets of data corresponded to the data at 380 Nm, 250 Nm and 180 Nm for constant temperature (60°C) and are labelled as ‘A’, ‘B’ and ‘C’, respectively. Twenty sets of AE data were recorded for every defect and load condition. Similarly, vibration data were captured at a 10 kHz sampling rate over a time window of 0.0256 s. The vibration data were averaged.

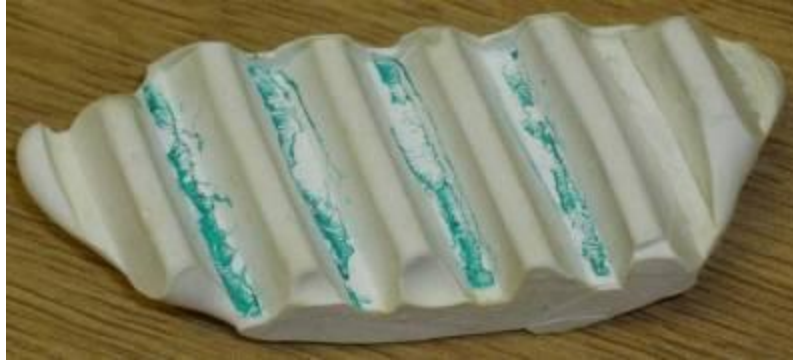
Figure 41 Surface replica from gear tooth

To address the reason for the decrease in AE levels with increasing defect size, as noted for test conditions A and D (defect-3 and defect-5), the approximate volume of each defect was calculated following casting of the defect onto ‘plaster’ so as to obtain a three-dimensional profile. The plaster was made of Calcium Alginate used in dental applications, see Figure 41. Plotting the volume removed against AE r.m.s. yielded an interesting observation, see Figure 42. A direct relationship between the defect volume and AE was noted for test conditions ‘A’ and ‘D’; in some cases, where the defect width was relatively wide but the volume removed relatively less (e.g., defect-5 was wider than defect-3 but the volume removed in defect-3 was more than defect-5), the AE r.m.s. levels were higher for the case of the larger volume removed. For cases B and C, the observation was not similar, particularly at defect-3. This has some implications, particularly in understanding other influencing sources of AE during meshing. This suggested the influence of the mechanism of interaction of the fluid within the defect cavity would appear to offer a source of AE activity. This particular observation was investigated further. To this end further tests were undertaken. A gear tooth was selected and holes of varying depth (volume) and a fixed diameter (2.5 mm) were drilled into the tooth, see Table 8 and Figure 42. After each depth was seeded, the rig was operated for 45 min (3,000,000 revolutions) before any AE data was recorded. This was to ensure the temperature remained constant throughout the tests. Results, presented in Figure 45, showed that an increase in AE r.m.s. was a direct consequence of increased cavity volume, strongly supporting the notion that the entrapped lubricant within a cavity (pit, spall, etc.) will also contribute to the level of AE measured. The sampling rate applied for these particular tests was 4 MHz and a total of 65,536 data points were recorded per file, of which over 25-data files were acquired for each volume condition. This is the first known attempt at investigating this phenomenon and will, in the fullness of time, lead to future investigations. A typical waveform associated with these volumetric tests is presented in Figure 45 which shows that the holes did not cause any material protrusions nor did they result in the generation of an AE waveform typical of the presence of a defect, as shown in Figure 33.

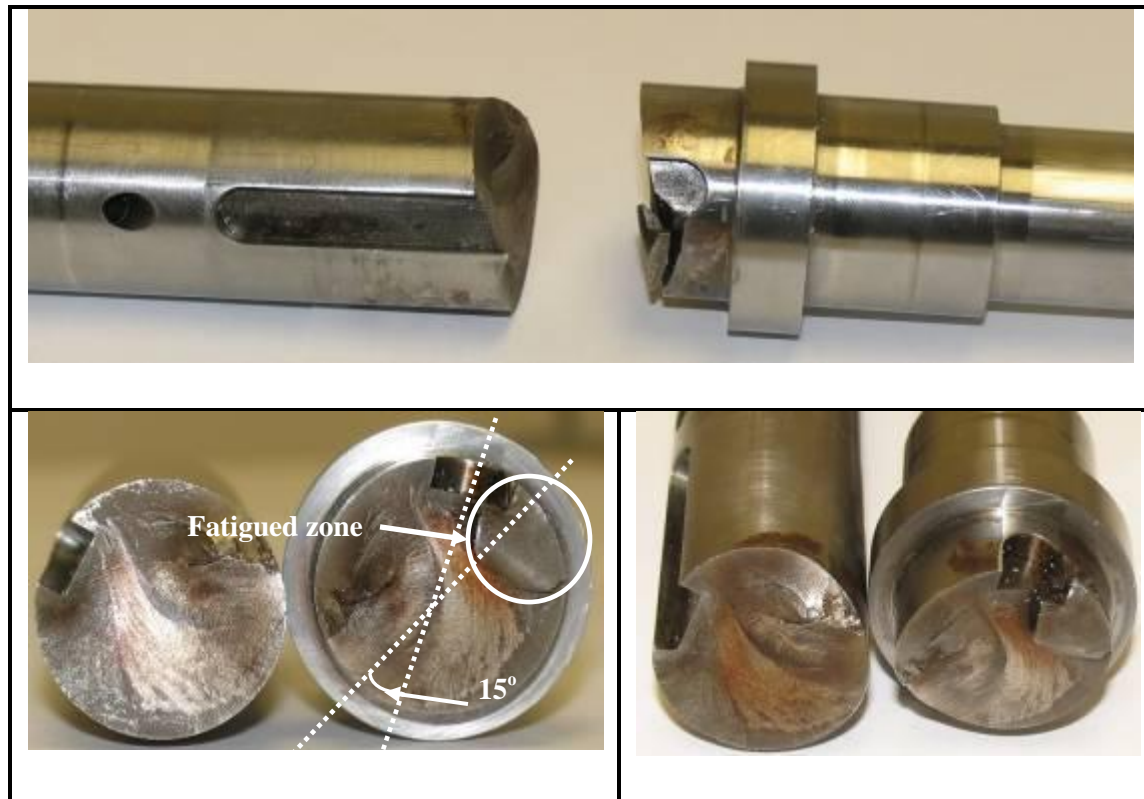
Figure 62 Fractured shaft
